Management of Dens Invaginatus with Fractured Ni-Ti Instrument: A Case Report

Sumbal Khan, Fawad Ali Shah

Department of Operative Dentistry and Endodontics, Khyber College of Dentistry, Peshawar, Pakistan

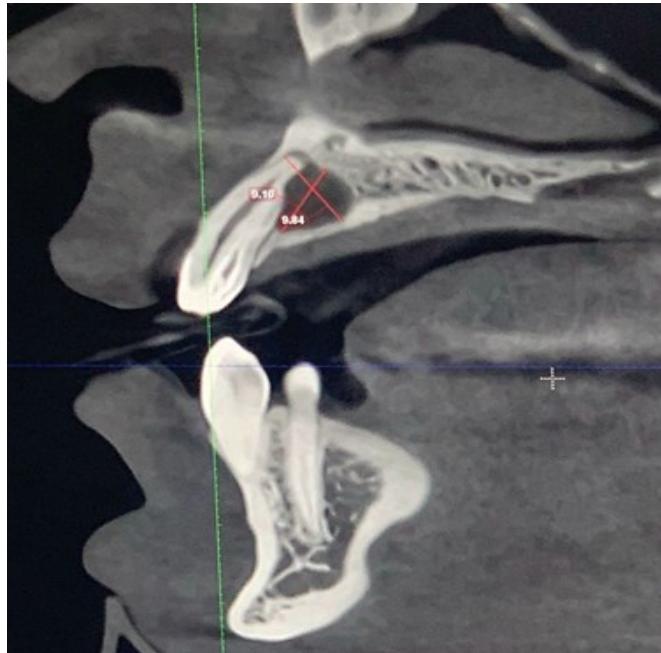
Figure 1: CBCT Sagittal full view and zoomed-in lesion area
INITIAL LESION: size: 9.10 x 9.84

Through cone-beam computed tomography (CBCT), the procedure was done to find out how much of the lesion was there and assess the structure of the canals. The CBCT image showed a dens invaginatus extending into the root and communicating with the periodontal ligament space through the apical foramen, which is exactly what Oehlers described as Type IIIb. According to the sagittal view, the lesion measured around 9.10 mm in width and 9.84 mm in height.

Results

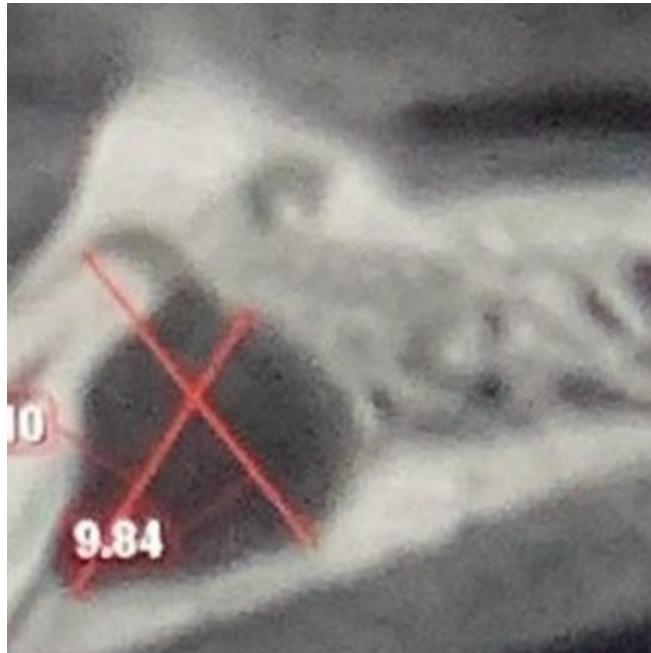
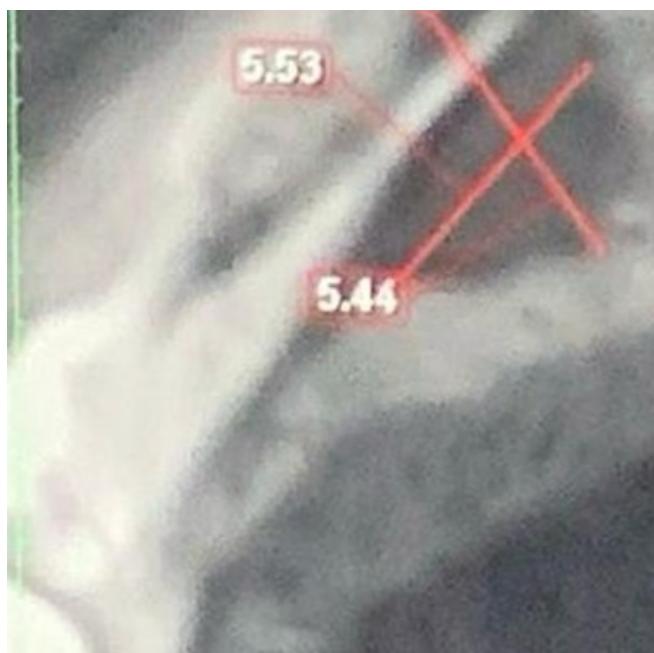
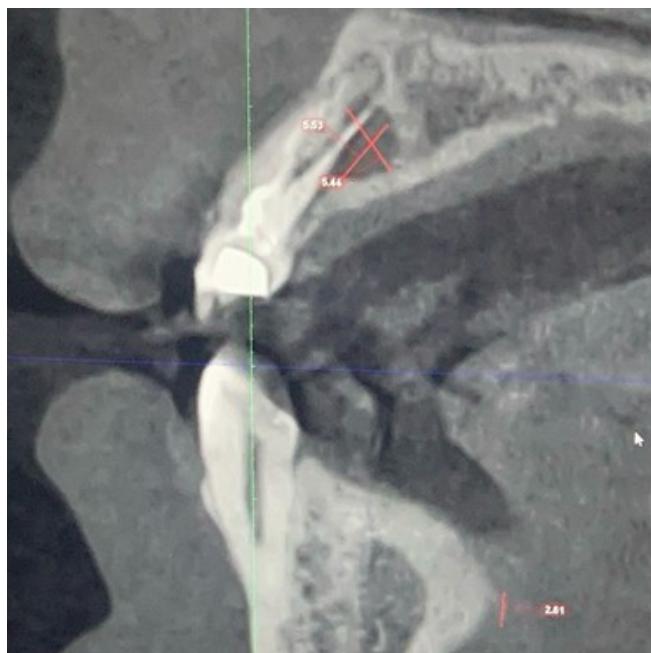
Figure 2. CBCT at 9 months showing reduction to 5.53 x 5.44 mm.

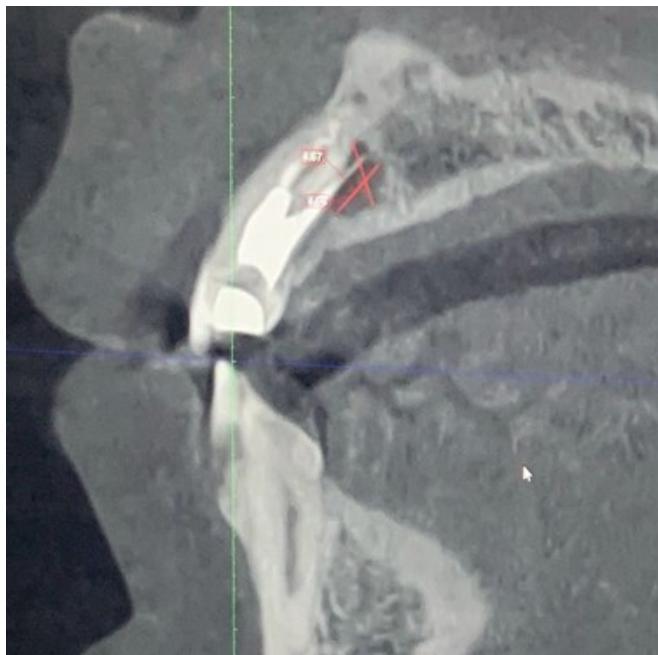
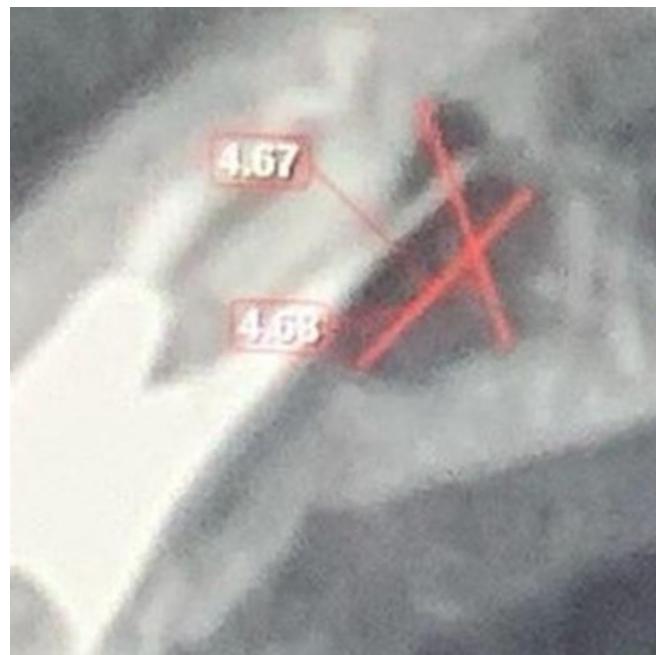
Figure 3. CBCT at 13 months showing further reduction to 4.67×4.68 mm.

curred. The lesion got smaller again, measuring 4.67×4.68 mm and it was shown by radiographs that bone had started to form around the edges of the lesion. The outcomes reveal that the extruded instrument did not cause any clinical problems; this proves that Ni-Ti instrument, a biocompatible material had not caused any hinderance of resolution of the periapical infection of the PDL space and bypassing it, while leaving it inside the canal was the right treatment choice for this case.
